Pan African University
Institute of Water
and Energy Sciences

Evaluation and Analysis of crystalline PV modules performance characteristics degradation in a sub-Saharan environment after ten years of exposure: Case study of Senegalese environment.

Master in Energy, Engineering track

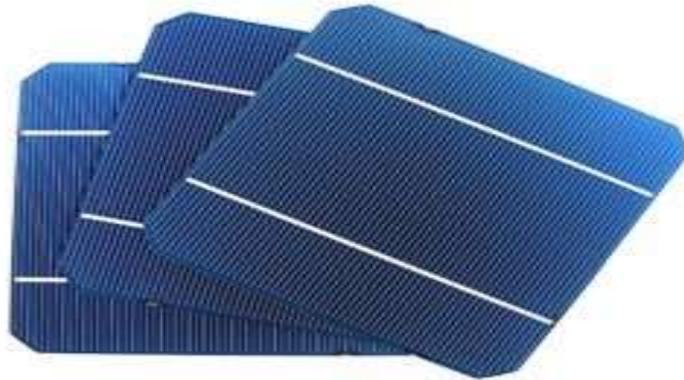
Figure 2: Monocrystalline solar cells

The monocrystalline (or single-crystal) cells represent the basis technology of photovoltaic energy and It still remains competitive despite its high price compared to the other technologies. Silicon manufacturing can be broken down into four stages: purifying silicon from a metallurgical grade (MG), produced mainly for the steel and aluminum industries, to a much higher purity polysilicon, then forming ingots of silicon of good crystallographic quality from this polysilicon and slicing the ingots into wafers, then processing the wafers into cells and, finally, packaging the cells into a PV module [7]. During the manufacturing, Liquid silicon is intended for the production of monocrystalline silicon mostly by the Czochralski process [8], to ensure a uniform junction during the process, time given and temperature are strictly controlled. And the result of this process is a single and very pure silicon crystal named monocrystalline cell. Its purity gives a uniform blue color (somehow black) (**Figure 2**).

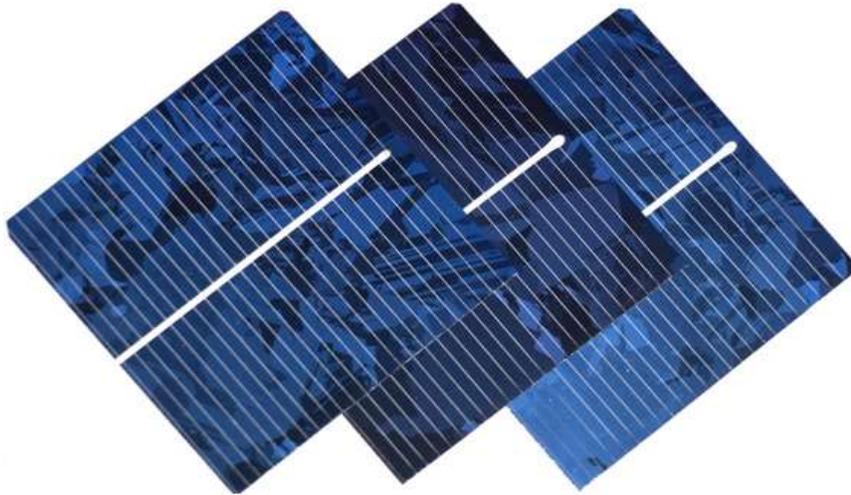
Figure 3: Polycrystalline solar cells

In order to reduce production costs, multi-crystalline silicon, less Expensive than monocrystalline silicon, has been introduced into the industry Photovoltaics since the 70s. Polycrystalline silicon production techniques are much more simple as that of monocrystalline thus far less expensive to implement [11]. Poly-crystalline silicon can be extracted from silicon by heating it up to 1500°C and then cooling it down to 1412°C, which is just above solidification of the material. The cooling is accompanied by origination of an ingot of fibrous-structured poly-crystalline silicon [12]. Whereas monocrystalline solar panels can be identified by their dark blue coloring, polycrystalline solar panels generally have a more blueish tint, and tend to look more scattered or fractured. Multi-crystalline silicon modules have a more disordered atomic structure leading to lower efficiencies, but they are less expensive. Current commercial poly c-Si modules have a higher conversion efficiency of around 13 to 16 %. The record lab cell efficiency is 20.8

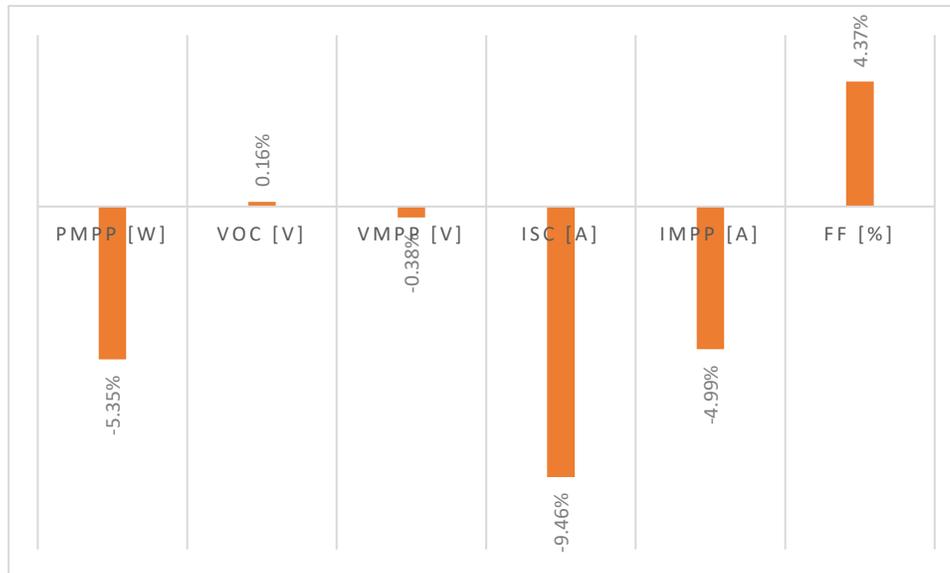
Figure 21: Performance Degradation of module A

The results obtained from the degradation calculations are summarized in **Figure 21**:

From **Figure 21**, it can be seen that the open-circuit voltage is not affected because the calculated degradation is positive. The V_{MPP} also expresses a very slight degradation of just -0.38%. However, the nominal and short circuit current degradation is striking and equal
