PAN-AFRICAN UNIVERSITY
INSTITUTE FOR WATER AND ENERGY SCIENCES
(Including CLIMATE CHANGE)

Master Dissertation

**TITLE: WATER QUALITY MONITORING AND VULNERABILITY OF THE COMMUNITY TO
CHOLERA A CASE STUDY OF CHITUNGWIZA ZIMBABWE URBAN AREA**

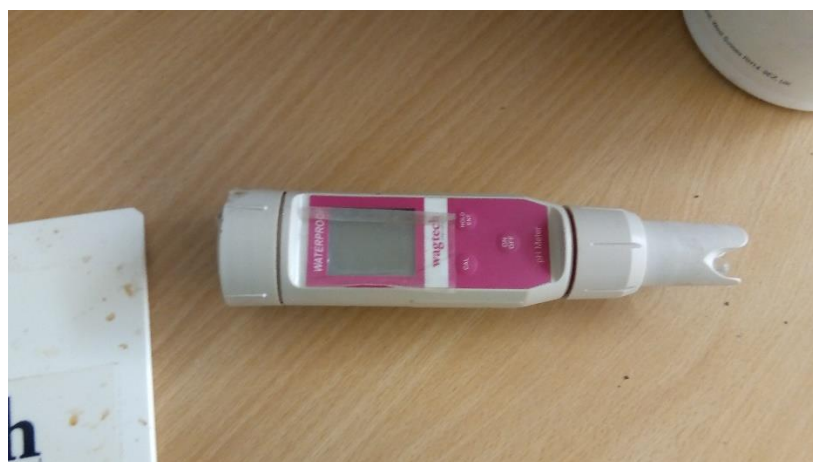
Figure: 10 Showing PH Meter

Water samples were collected using clean 500ml glass bottles, and transported to government laboratory in a cooler box, with ice within 3 hours of collection and analyzed using standard procedures recommended by WHO. Water parameters such as pH were sampled on the field using ph Meter, with the assistance of a microbiologist

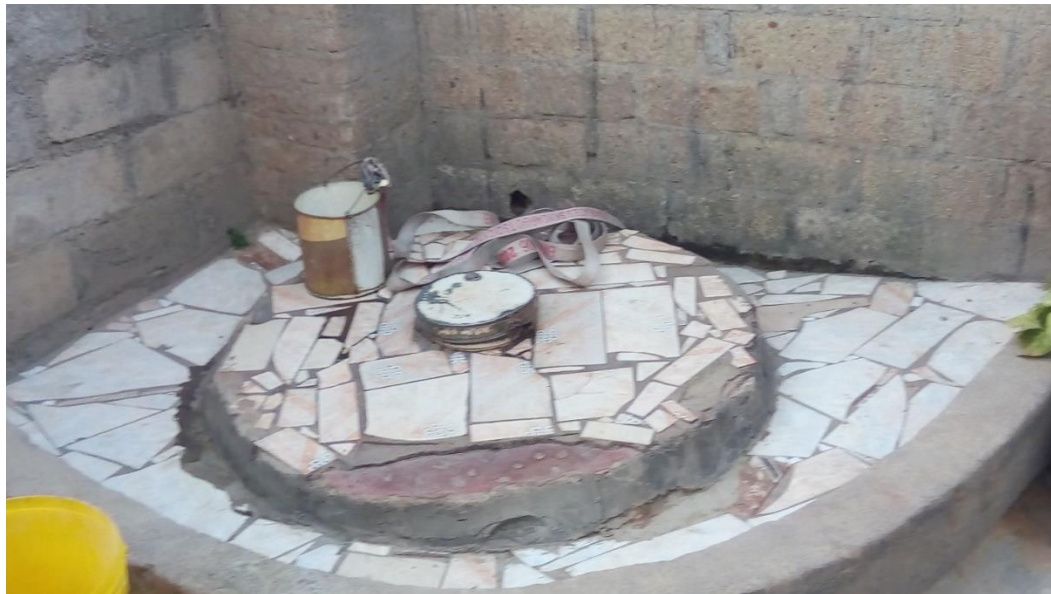
Figure 12: Hand dug well sanitary condition in Zengeza

Below is a photo of the well that was contaminated, the rope was not properly cleaned and the bucket. The well was not controlled and a huge number of people including water vendors who came and fetch the water, lack of monitoring of the water source exposed it to fecal contamination. According to Jenkins (2015) unsanitary behavior such as not washing the hands after using the toilets then using the rope to fetch water could potential pollute the water

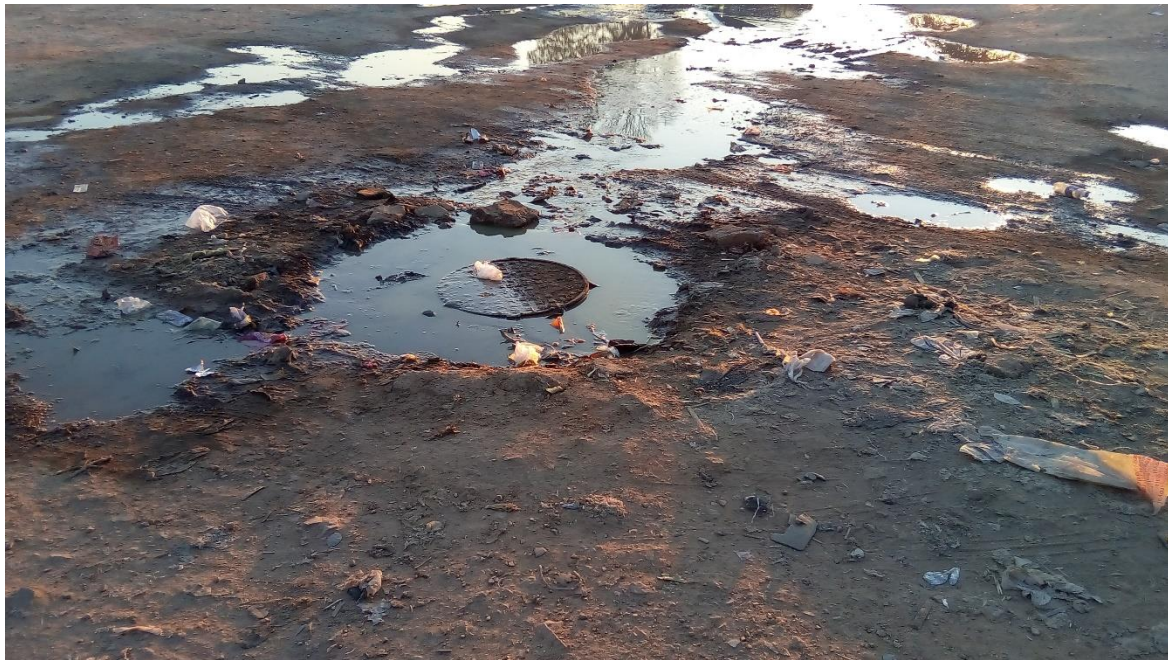
Figure 18: Exposure of the community to sewer bursts in Chitungwiza

The above photo shows sewer bursts and this is a clear indication of population pressure on the services and the slow response of the Council has caused diseases and exposure to cholera to be high.

The efficiency in addressing complaints is very low at 60.5% which has exposed the community to diseases as a result of sewer bursts which are caused by population pressure against the dilapidated infrastructure. Council has to respond rapidly to sewer bursts promptly in order to reduce the vulnerability of the community to cholera outbreak.
